Disaster Preparedness and Mitigation Measures of the Kapkese Landslide in Kipkelion District, Kenya

Bernard Kipsang Rop

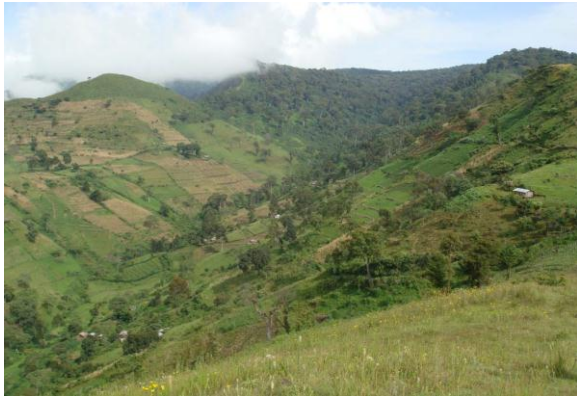
Plate 1: Kapchorua area showing over-cultivated areas in steep slopes with the forest area at the background of the first photo.

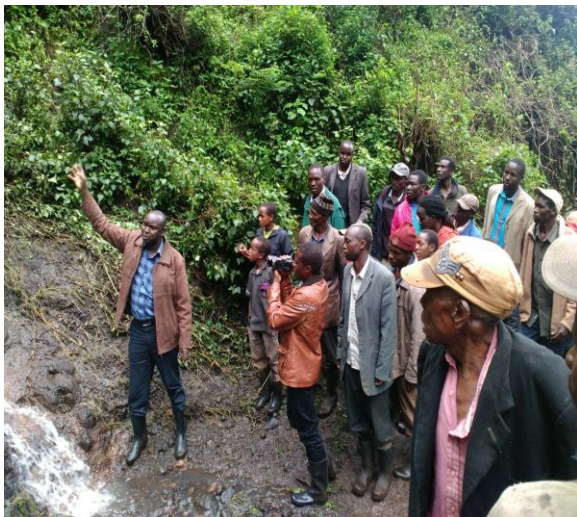
Plate 2: Very steep Kapkese slope where landslide occurred in December 2015

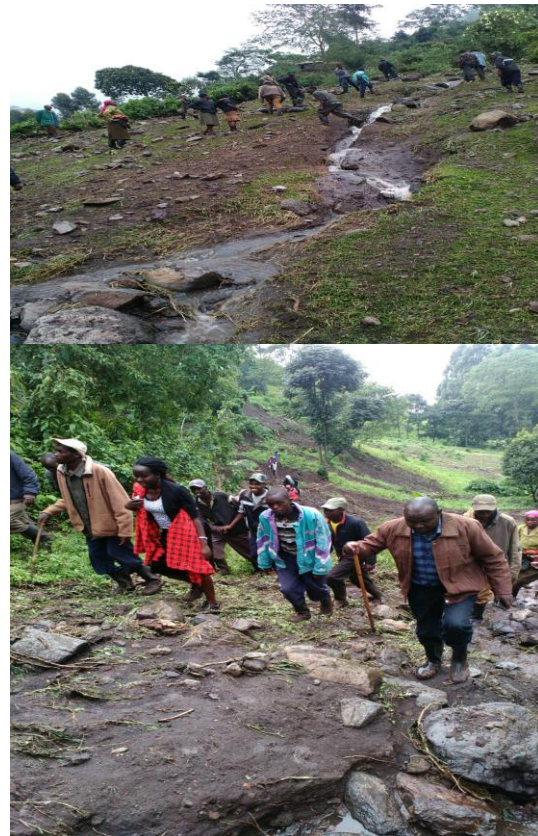
Plate 2: Kapkese's Landslide site with gushing waters on slopes ranging from 60° to 80° , in a

general westward direction (Area MP with inhabitants inspecting the disaster-prone area).

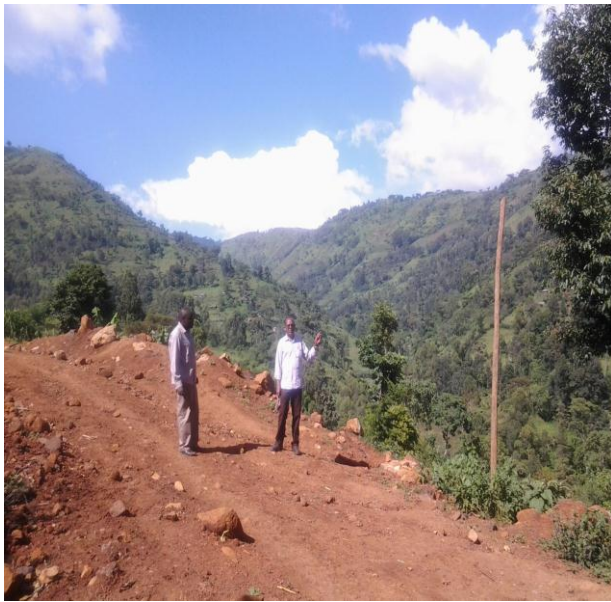
Plate 4: Photograph of Kapkese steep slope (behind Dr. Rop background) and a river valley (December 2015).

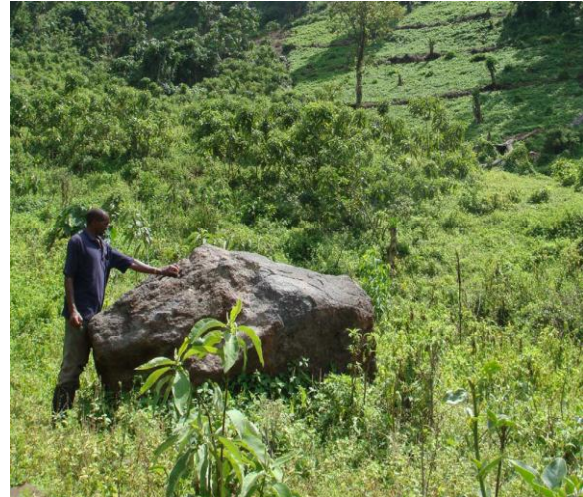
Rock falls are common on all the slopes below the ridges in the area. They are however more common on the steeper slopes that are under cultivation, especially during or after heavy rains.

This situation is clearly observed on the western slopes of Kapchorua ridge. The boulders are of various sizes which rarely exceeds 2m in diameter. The slope of the ridges on the inhabited area has an inclination angle of up to 60°.

Plate 3: A rock that rolled from the top of the ridge in September 2008

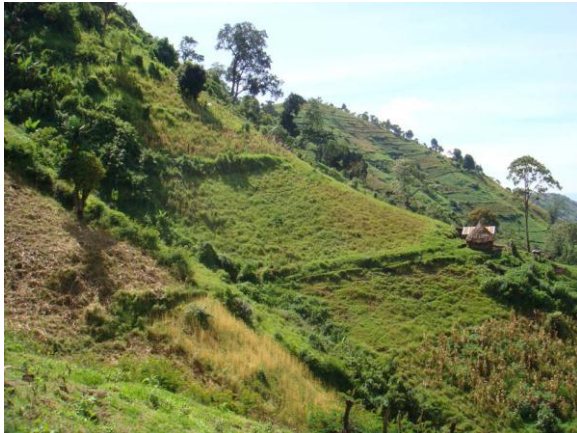
Plate 5: A homestead constructed on old landslide debris, an unstable ground.

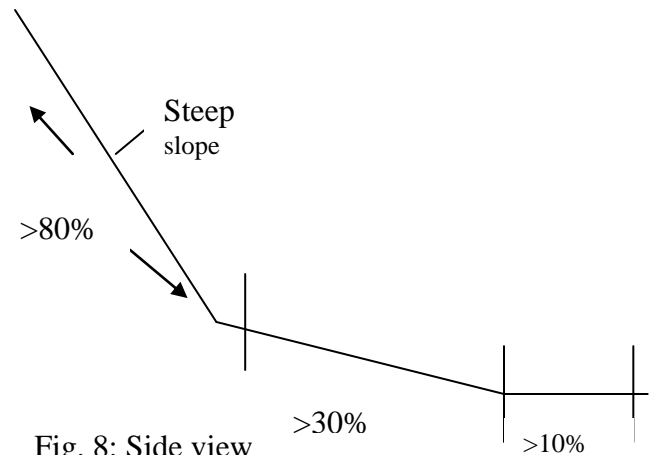
Fig. 8: Side view cross section (Not drawn to scale)

1. One of the most likely factors that led to the mud flow is inappropriate land use.
2. The slope in question consists of three categories of slope namely (Fig. 8); 80% along the Kokwet escarpment with an east/west aspect with a slope length of 100-200m 20-35% below the above slope for about 50m 20% at the bottom.
3. The steepest slope was deforested and cultivated in some places and some and some with dwellings. These are the structures that were destroyed together with human life on the disaster struck.

The greatest risk of mud flow is >80% slope. But again, it is only that slope which had been deforested, and cultivated for maize (annual) crop. Where there were human settlements.

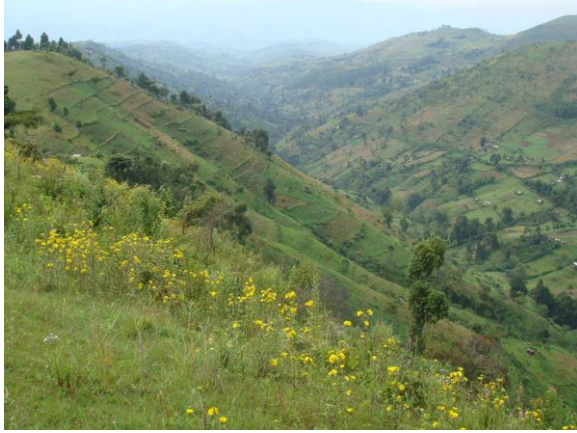
In this area, the locals cultivate the steep slopes and are continuously removing the vegetation cover on the upper parts of the slopes (Plates 6, 7).

Plate 6: Steep slopes that have been cleared for cultivation. Note the poor soil conservation measures

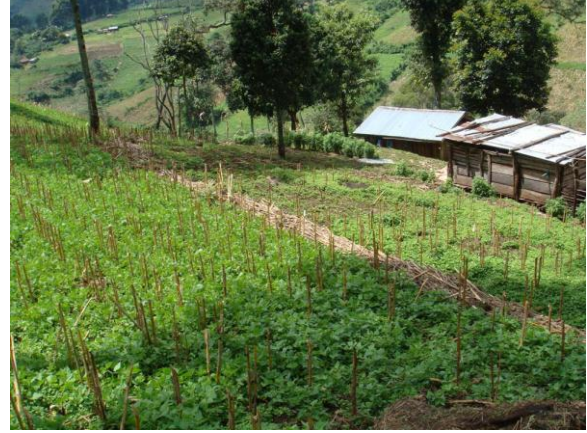
Plate 7: Cultivation and settlement on the steep slopes

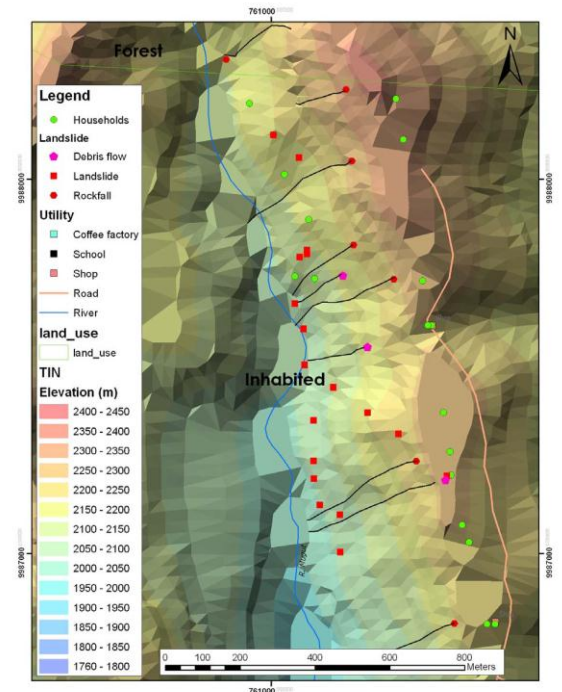
Map 4: Location of landslides on the map. Debris flow and rock fall paths are shown by the black lines

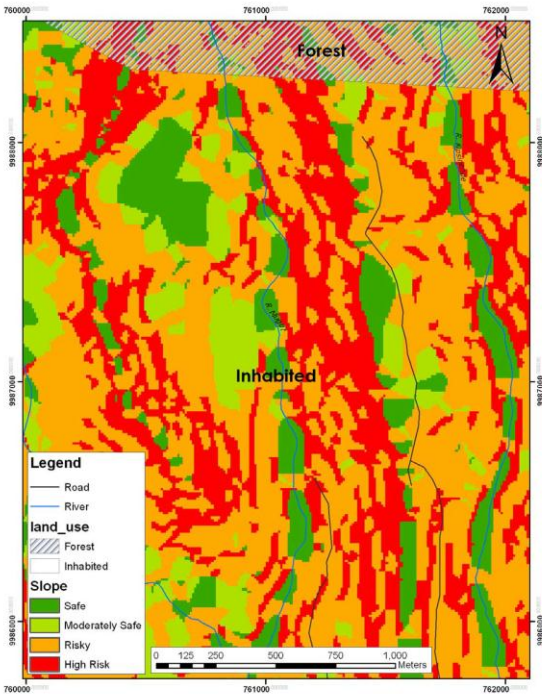
Areas with a slope of between 0° and 16° were categorized as "Relatively Safe", 16° to 32° as "Moderate Risk" to landslides, and above 32° as "High Risk".

Map 5: Landslide Risk map of the area
