Assessment of the Extent of Land Degradation in the River Lobo Watershed of Baringo County, Kenya

Abstract: Increased human population pressure and climate change constitute the global underlying root causes of accelerated and devastating land degradation processes in the Arid and Semi-Arid Lands (ASALs). River Lobo watershed, located at the lower part of the Lake Baringo Catchment, is not an exception. The area is characterized by severe vegetation degradation that has resulted in extreme soil deterioration. This study aimed to determine the extent of land degradation in the watershed with specific objectives of determining the vegetation cover and composition, observing signs of accelerated soil erosion as well as assessing the socio-economic status of the inhabitants in the watershed. Tools for data collection included structured questionnaire, observation schedules and oral histories. The measured variables were analysed using a one-way ANOVA ($\alpha = 0.05$) and correlation analysis. The results indicated that the whole watershed is degraded with 87.5% of the watershed being highly degraded and the remaining 12.5% moderately degraded. The overall vegetation cover was 59.6%.

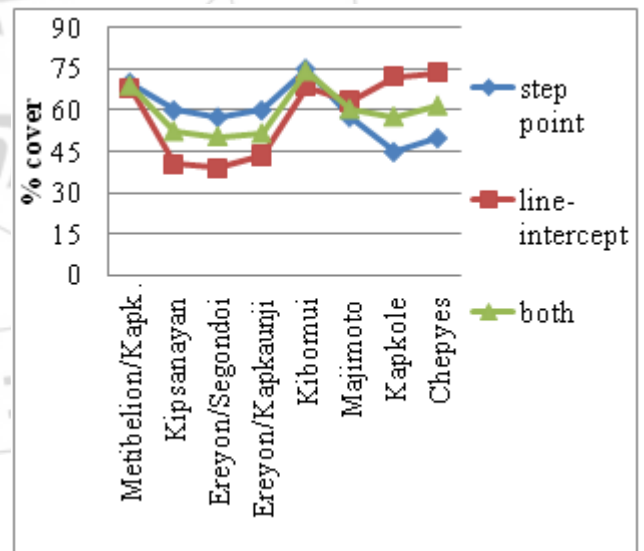
Figure 2: Cover along each transect/ village

Figure 2 below illustrate the general trend for vegetation cover in the river Lobo watershed. The upper section (Kapkechui location) of the watershed recorded the highest cover of 71.5% (Metibelion/ Kapkundul and Kibomui villages). The cover seemed sufficient in providing adequate protection to the soil in the area. There were few incidences of visible erosion in the location and of great environmental significance was the seasonal spring at Chepchukuko. People fetch water from the spring. The spring is almost 3km from the main source of river Lobo where the locals hold that there was once a spring. As is the case with most water sources, such as lakes Baringo, Bogoria and Nakuru, in the rift valley, quantity of water in the spring has increased in the last three years.

Stoddart *et al.* (1975) indicated that a >70% basal cover provides an adequate protection to the soil in the rangelands and forage for livestock production. Based on field observations and cover results of Kapkechui location, this study affirms the figure for river Lobo watershed. Cover is a key factor in combating land degradation. The middle section (Simotwe location) of the watershed was found to be most hit in terms of cover degradation. The location recorded the least cover of 51.4%. Transect 3 and 4 (Ereyon/Segondoi and Kapkaunji villages) recorded the least covers (50.36% and 51.54%, respectfully). The two transects constitute the priority areas for future vegetation cover

rehabilitation. Cover in lower section of the watershed (Koibos location) was 59.8%. Koibos location is rocky and it was observed that the rocks were so large that at some points there was no vegetation at all. More crown cover was recorded in the location compared to the middle section and upper section. The high crown cover can be attributed to the many trees recorded in the location especially the *Acacia species*.

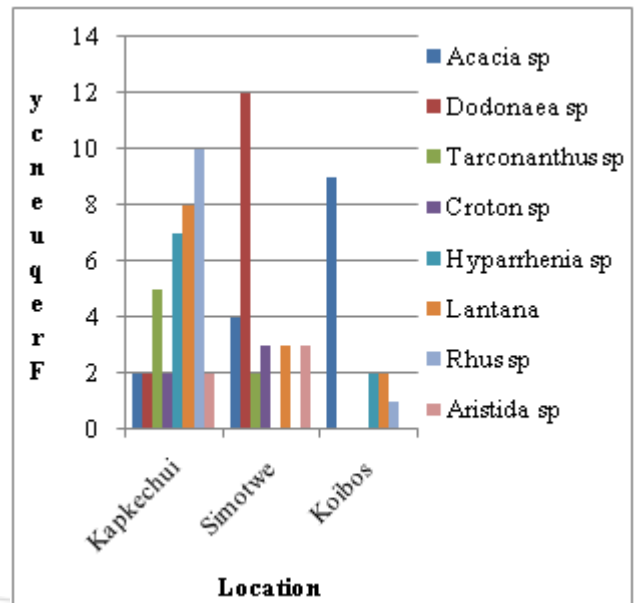
Figure 3: Cover of some dominant plant species in the river Lobo watershed

The results of this study indicated that the flora of the watershed contains 42 plant species belonging to 34 genera. As indicated in the previous section; vegetation cover has declined and this may be as a result of reduced number of plant species in the watershed. Probably, some species have disappeared from the watershed due to the poor soil condition. Some of these species include *Boscia angustifolia* (Lito), *Acacia drepanolopium* (Ingowe) and *Osyris compressa* (Marimarwe). On average, 7 ± 3 plant species were recorded per plot. This implies that the watershed ecosystem is less diverse and this may be contributing to its inefficiency in withstanding environmental stress. Species richness in the three locations was almost uniform. The climax vegetation in the watershed was probably that of a tropical Savanna (Stoddart *et al.*, 1975). Results of this study demonstrate a shift from the Savanna vegetation to shrubland as most of the dominant plant species currently are classified as shrubs (Figure 3).

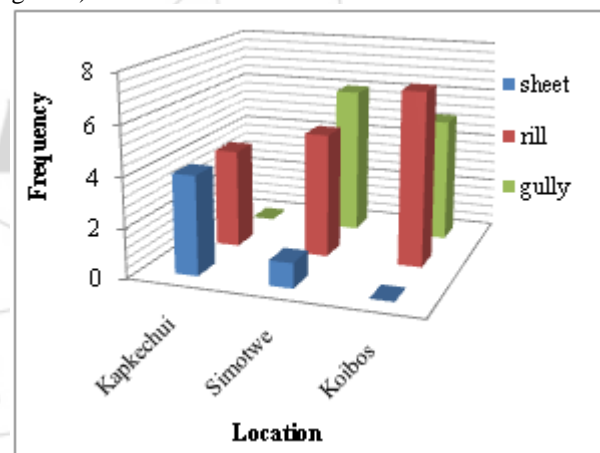
Figure 3: Visible erosion in the three locations

The differences in the proportion of erosion recorded in the land cover form and that of the questionnaire can be attributed to the fact that farms near homesteads are taken care of as compared to those further away. One expects to see no/less rills and gullies near homesteads and vice versa. Similar observations have been recorded by Tenge *et al.*, (2004). Sheet, gully and rill erosion were prominent in Kapkechui, Simotwe and Koibos location, respectively (Figure 4).

The erosion scenario in the middle section can be explained by the less vegetation cover. The other contributing factor is the low organic matter content which makes the soil aggregates more unstable and susceptible to erosion. In spite of the good crown cover recorded in Koibos location, rills and gullies are outstanding in the location. Rill and gully formation in the lower section of the watershed can be attributed to the high rock cover and the cumulative effect of increased surface runoff from the upper and middle sections of the watershed. In addition trees and shrubs are not effective in protecting the soil.
