Disaster Preparedness and Mitigation Measures of the Kapkese Landslide in Kipkelion District, Kenya

Bernard Kipsang Rop

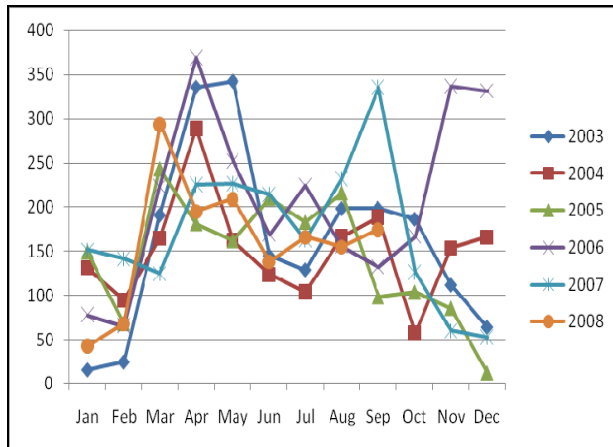
Fig. 7: Graphs of rainfall for the last six years

The highest annual rainfall received in the last six years was in 2006 when 2504mm was received. The lowest rainfall in the same duration was in 2005 with 1711.1mm. In 2003 between April and May, a total of 678mm was recorded (335.6mm in April and 342.4mm in May). This was when massive landslides occurred in the area and killed four family members.

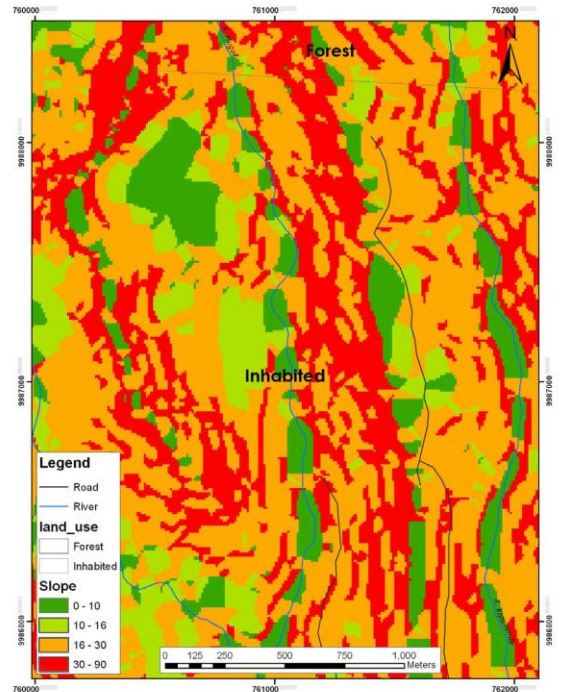
Map 3: Slope map of the area

Areas with a slope of between 0° and 16° were categorized as "Relatively Safe", 16° to 32° as "Moderate Risk" to landslides, and above 32° as "High Risk".

The risk associated with smaller slope is because the slopes have been generally cleared for cultivation. This is mainly due to expansion for more fertile land where artificial fertilizers are not required by the crops.

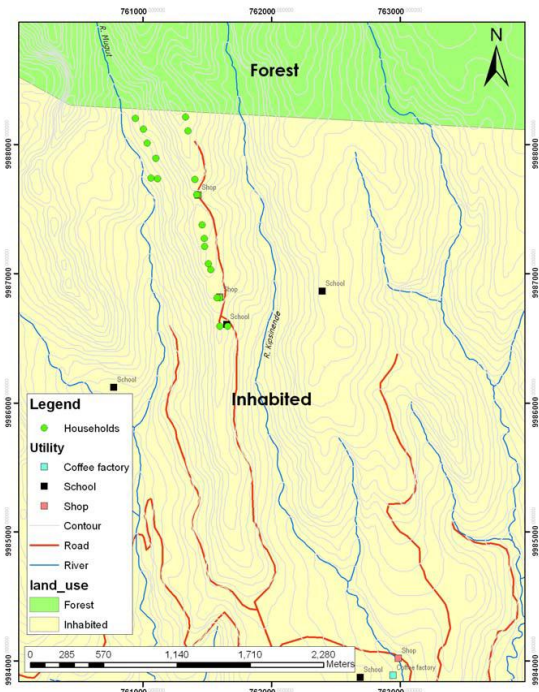
Map 2: Land use/ Land cover of the area. Note that the households have been highlighted for the area most affected by landslides. Other areas are more populated
